# Manhole Inspection Summary

Manhole # S31M\_\_004MH

Insp Date: **12/31/08 12:42 PM**

**Location** Address: **Russel St.**

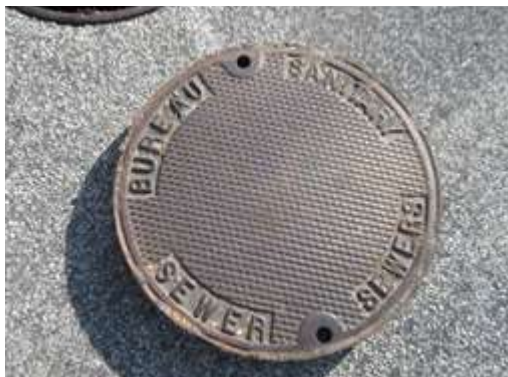
Miscellaneous

MH cover

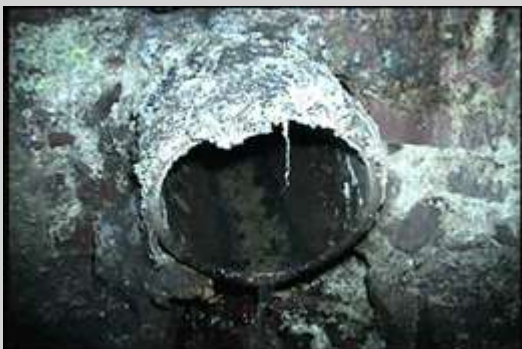
5 O'Clock Inflow

Pipe Height: **8.4** (in.) Rod and Bar (Angled)  
Pipe Material: **Clay** ☐ Pipe Lined  
Invert Depth: **15.00** (ft.) Flow Characteristics: **None**  
Deposits: ☒ **None** ☐ Mud ☐ Sludge ☐ Debris ☐ Grease  
Silt Depth: **0** (in.) Deposits Extent:  
Infiltration: **None** Pipe Seal Cond: **Sound**

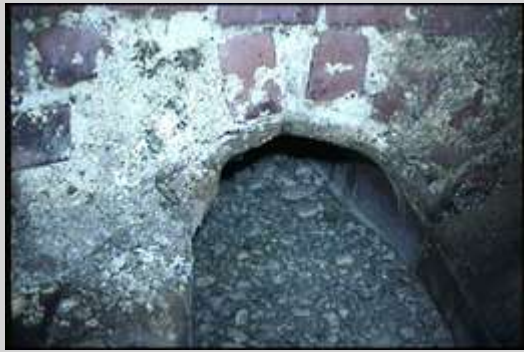
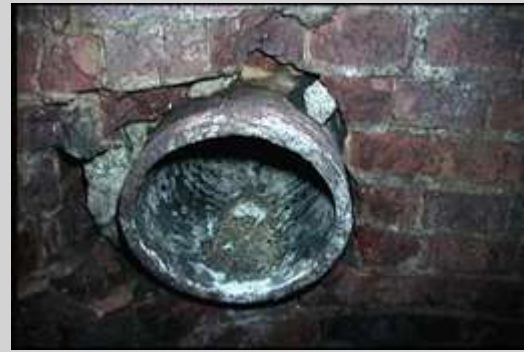
6 O'Clock Inflow

Pipe Height: **8.4** (in.) Rod and Bar (Angled)

Drop: **Outside** Rod and Bar

Drop Condition: **Open**

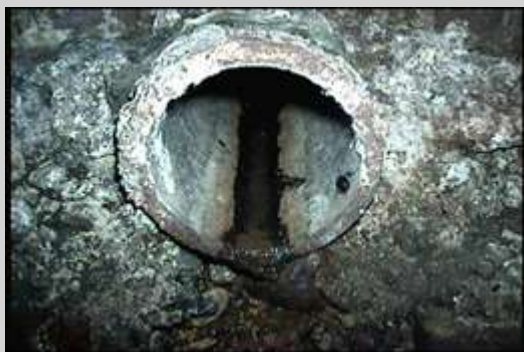
9 O'Clock Inflow

Pipe Height: **8.4** (in.) Rod and Bar (Angled)

Infiltration: **None** Pipe Seal Cond: **Sound**
